Birkenhead Priory Conservation Management Plan

Volume 2: Gazetteer

LLOYD EVANS PRICHARD

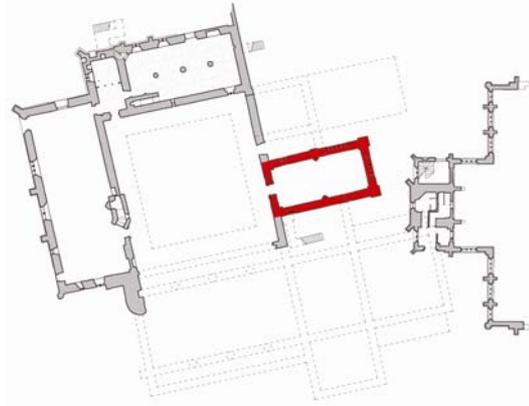
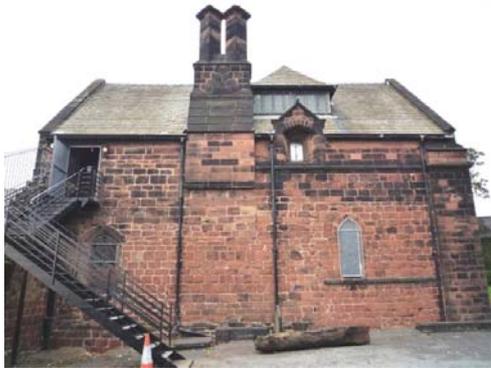
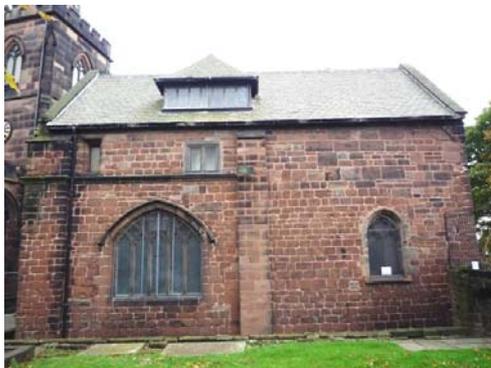
- Coursed and squared solid stonework with a Westmorland green slate roof, two storeys, and two bays in length.
- **West elevation** - gave on to the former cloister; an indent for the roof flashing (1) of this is cut into the wall of the scriptorium.

- Stainless steel wire guards over many windows.
- Perimeter drainage trench around building (16) excavated at time of Kirby's restoration.

Negative/intrusive: The metal fire escape, window guards

1. The external metal fire escape is a negative/intrusive feature and should be renewed or replaced with a more sympathetic design.
2. The external wire guards are negative features. If protection is required they should be replaced in time with stainless steel wire guards or other sheet protection fitted on brackets, shaped into the individual lights, and not over-sailing the stonework and tracery divisions.

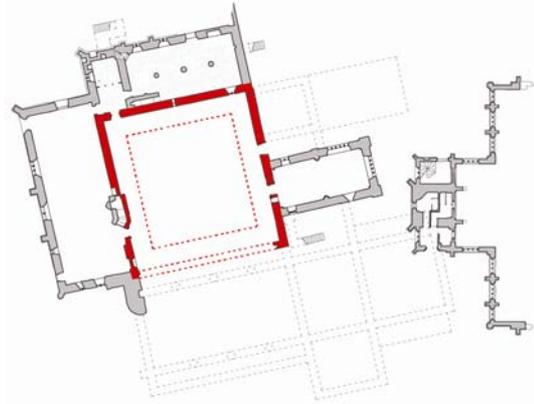
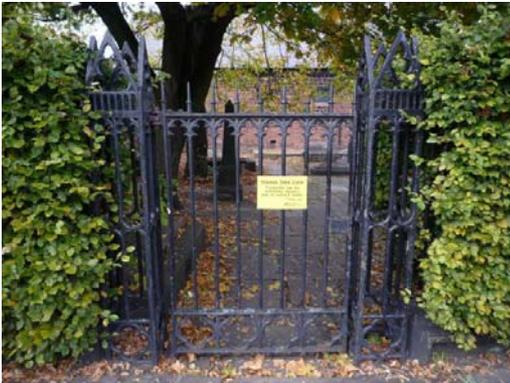
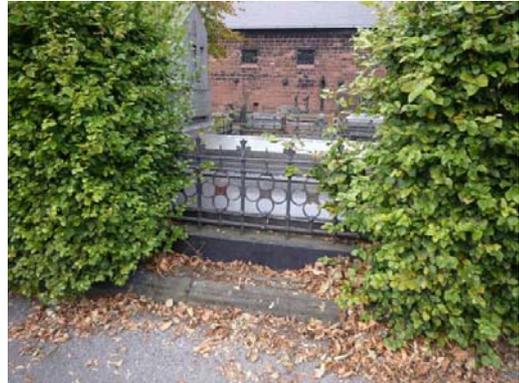
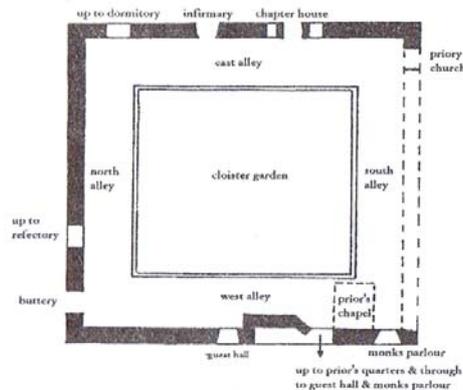
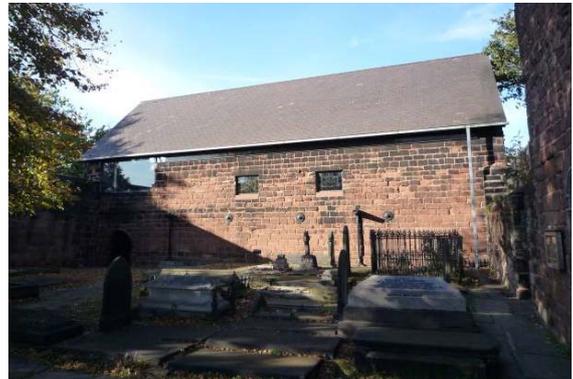
- To the south of the door to the monks' parlour tooting (26) for the priory church is visible.
- Cloister now part of the burial ground and contains a number of marked graves of 19th and 20th century date. Includes a large railed monument towards the northeast corner, the granite monument to John Laird MP in the southeast corner (28) with a railed enclosure, and an obelisk monument nearby.

- Ground level is now considerably higher, as can be seen in front of the blocked door (27) to the monks' parlour.
- Southern boundary of the 'burial area' enclosed by a cast iron gate (29) and railings of early 19th century character, incorporating trefoils and quatrefoils, possibly designed by or for Rickman.

- Railings to west of gate are largely obscured by a modern beech hedge; east of the gate there is also a hedge. Railings have been largely removed here at some point (visible in photographs of 1950).

1. Some of the monuments are in need of repair. It is the families' responsibility for repair of individual monuments, although it is common for work to be carried out on their behalf as often families are either untraceable or unable to afford repair.
2. Reinstatement of the missing railings on the southern boundary should be considered, and possibly the removal of the hedge.

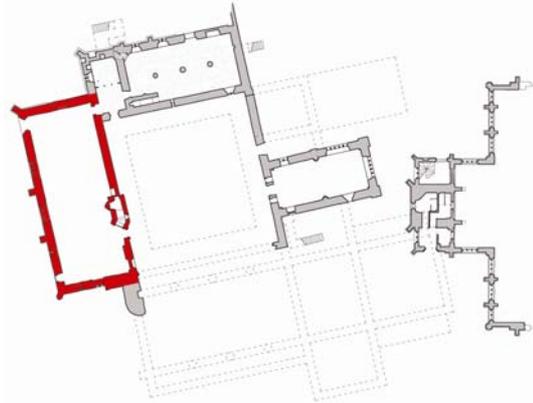
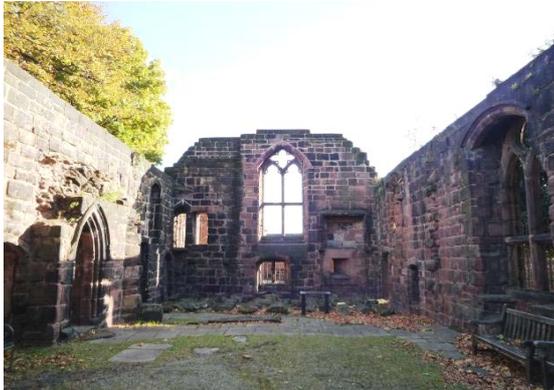
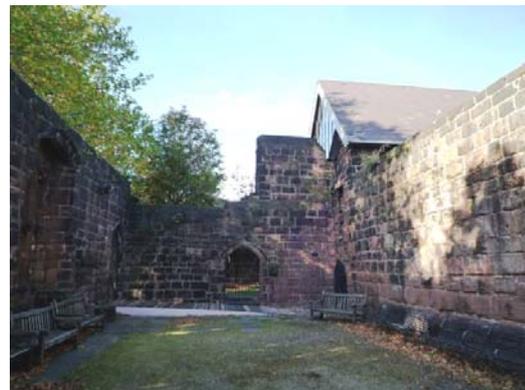
- Solid, coursed squared red sandstone rubble with dressed openings.
- **East wall** - large areas of rebuilding c1913, especially in the northern half.

- Originally had three doorways from cloister, connecting to the guest hall (22), prior's quarters (23) and monks' parlour (24). The first of these doors, to the guest hall, has been blocked on east face.

<p>Designation: Scheduled ancient monument.</p>
<p>Specific items for consideration:</p> <ol style="list-style-type: none">1. The medieval stones at in the monk's parlour area appear abandoned – they require cataloguing and properly displaying with interpretation to make full use of them as an asset.2. The replacement of the demountable ramp with a more visually acceptable means of facilitating circulation is desirable, subject to SMC.
<p>Relevant Issues & Policies: 4.1.5, 4.2.3, 4.3.1, 4.3.2, 4.4.6, 4.6.3</p>
<p>Key references (Author/Year/Page): Scheduling description; list description; Croasdale, 1994, 11; Mason and Hunt, 1854</p>

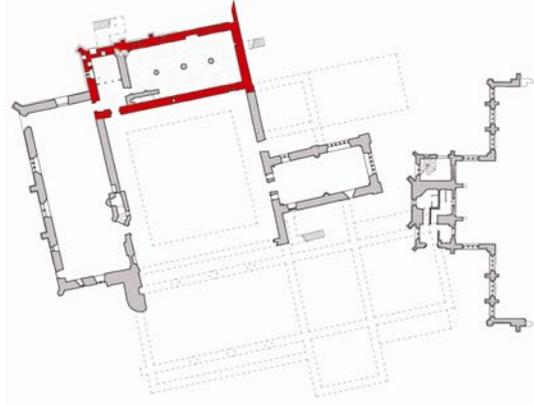
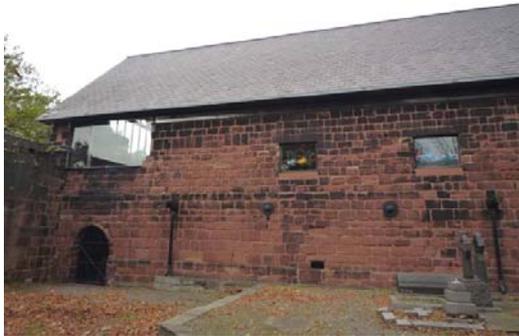
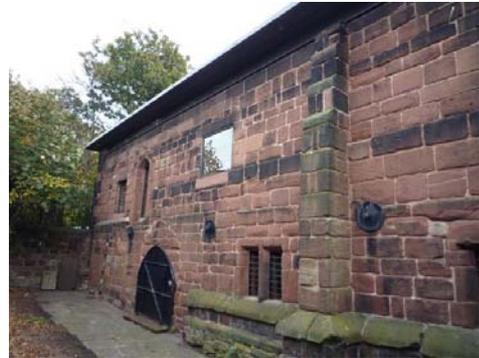
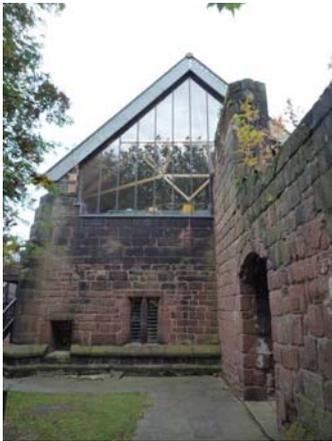
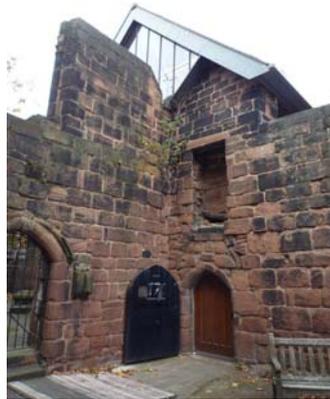
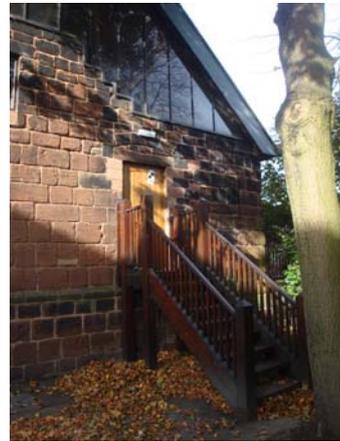
- Near the corner, the plinth is broken by a rectangular opening (52), for one of two stone cupboards set into the walls.
- First floor level stonework is much renewed.

1. Structural movement and possible questionable detailing of new 1993 roof structure.
2. Inadequate access up into the first floor refectory (external, uncovered, inaccessible for more heavily disabled users)

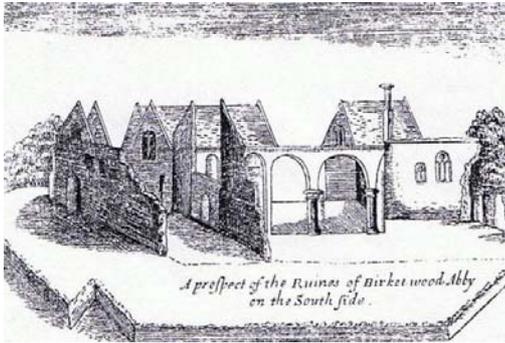
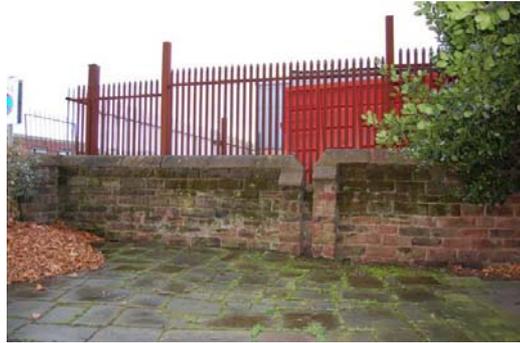
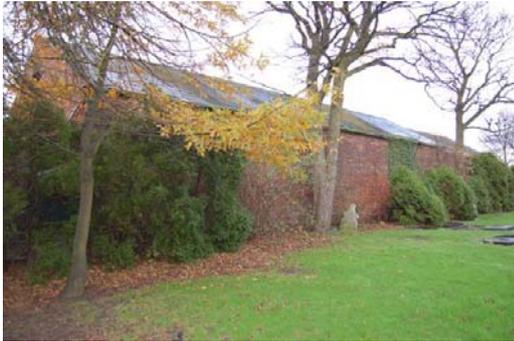
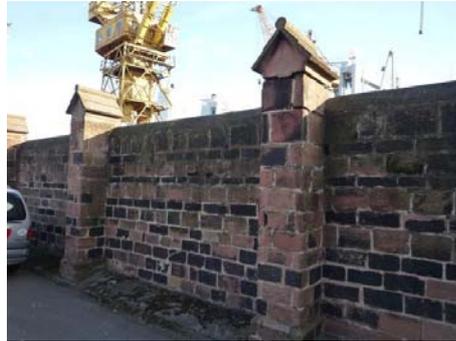
<p>Specific items for consideration:</p> <ul style="list-style-type: none">• The third section of the northern boundary wall is in need of repair.
<p>Relevant Issues & Policies: 4.1.5, 4.3.1, 4.3.2, 4.4.1, 4.6.3</p>
<p>Key references (Author/Year/Page): None</p>
