# Section 19 Investigation Report

Stockport Metropolitan Borough Council

June 2016 Flood Events

D03 | V01

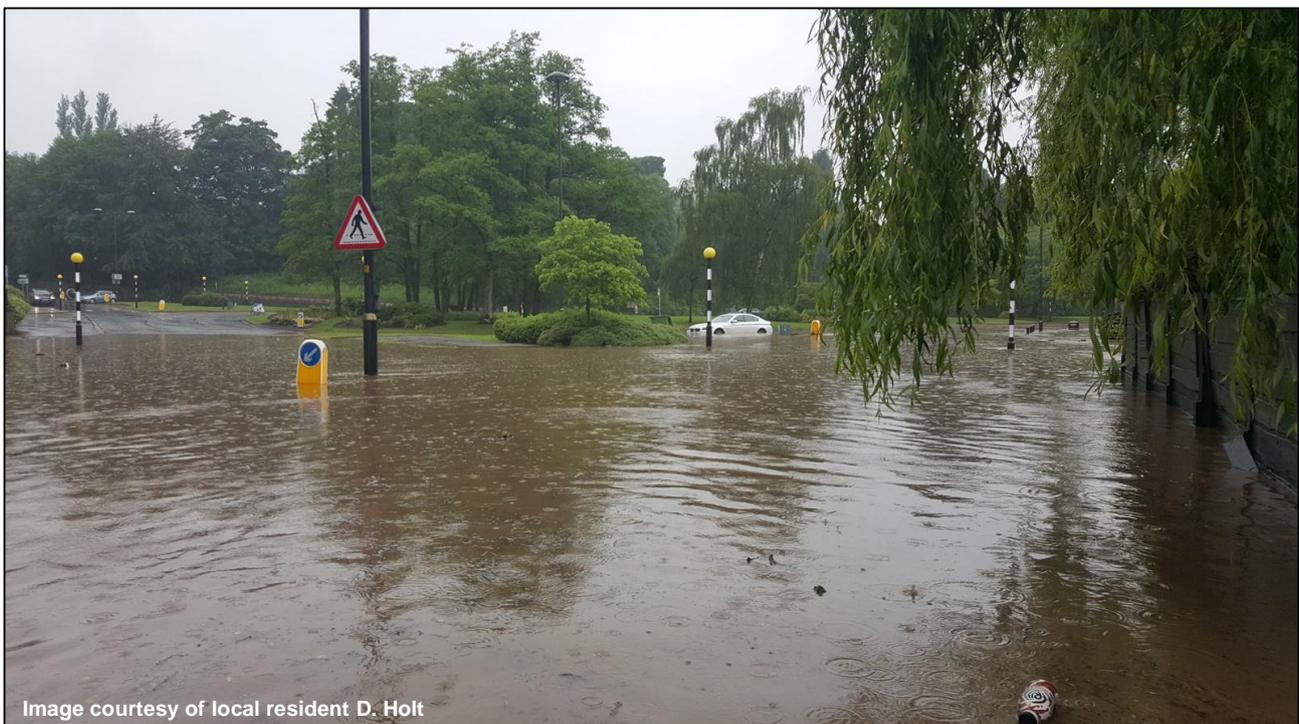
Figure 1.1 : Flooding of Bramhall Green roundabout - 11 June 2016

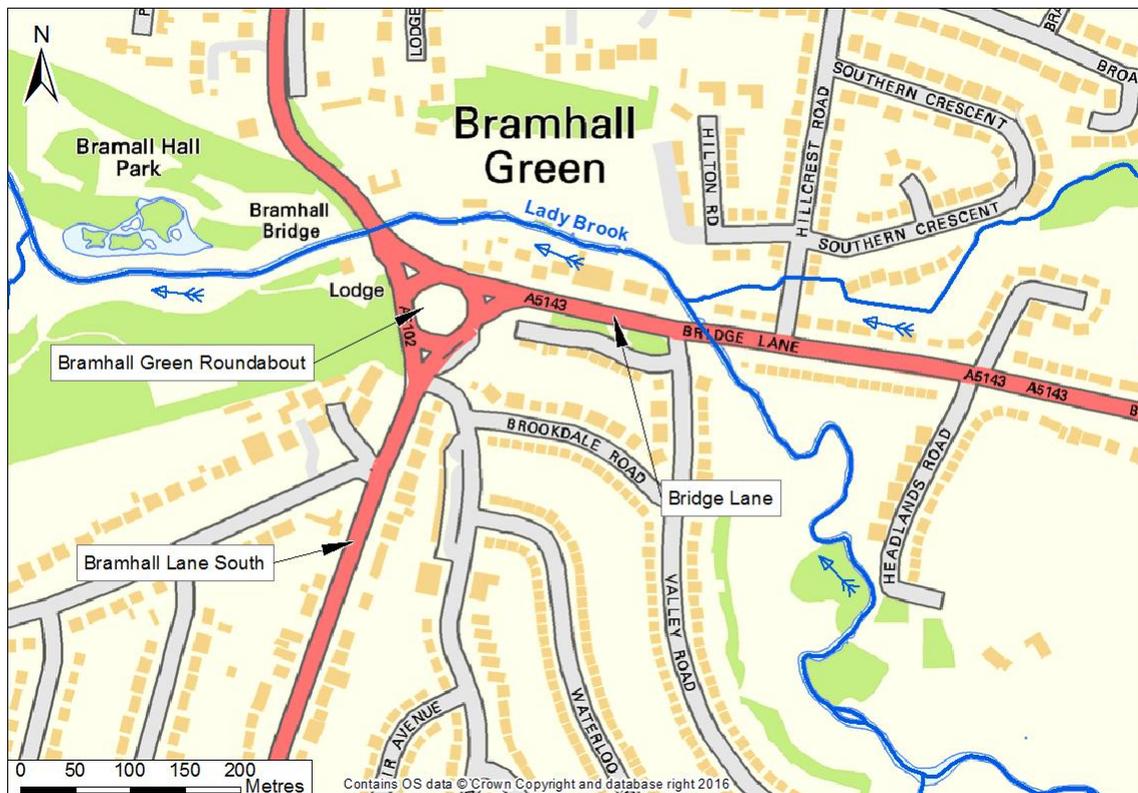
Figure 3.1 : Bramhall site overview

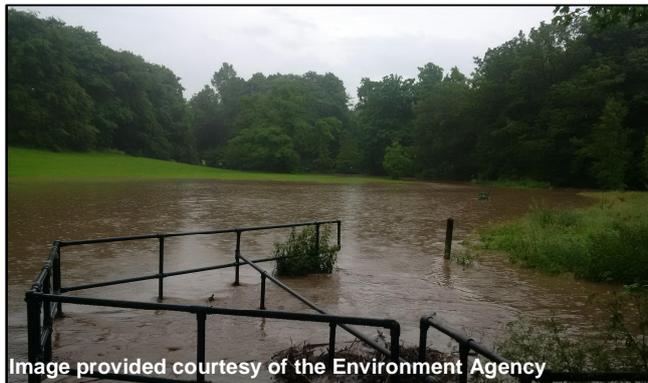
Figure 3.4 : Torkington Park Flooding – 11 June

Torkington Park was also flooded (see Figure 3.4) and both Torkington Road and Hazelwood Road were closed to traffic because of flooding on the highway (see Figure 3.5).

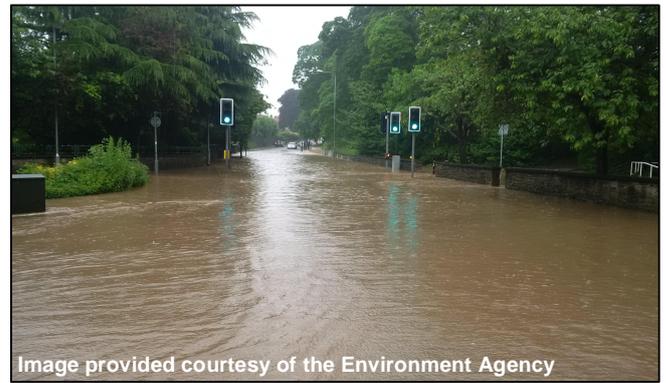
Figure 3.5 : Torkington Road Flooding – 11 June – looking east from Hazelwood Road junction

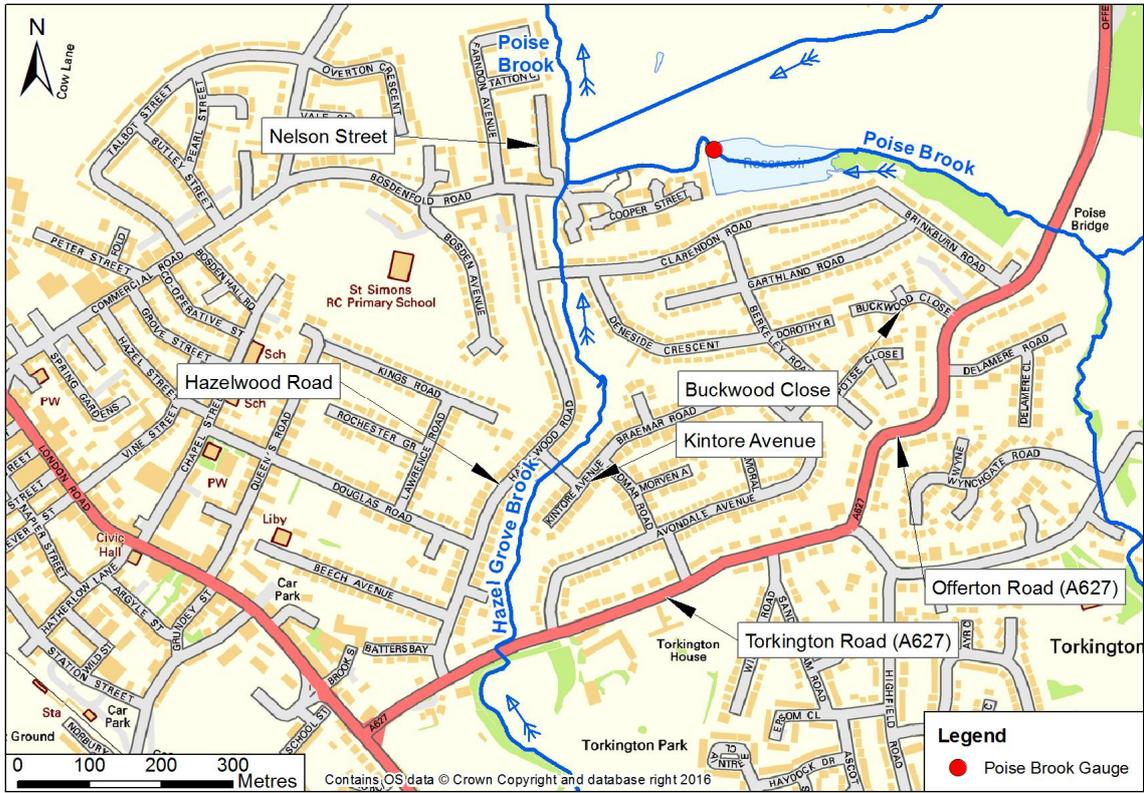
Figure 3.6 : Hazel Grove (north) site overview

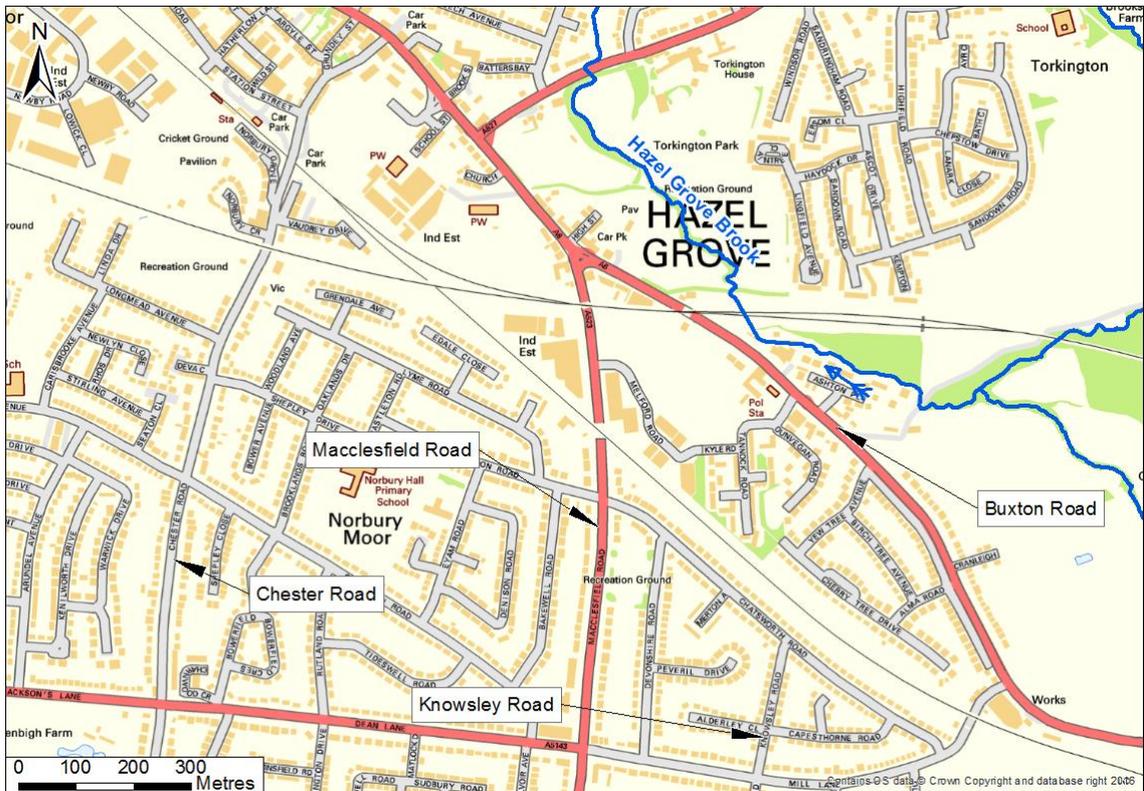
Figure 3.7 : Hazel Grove (south) overview

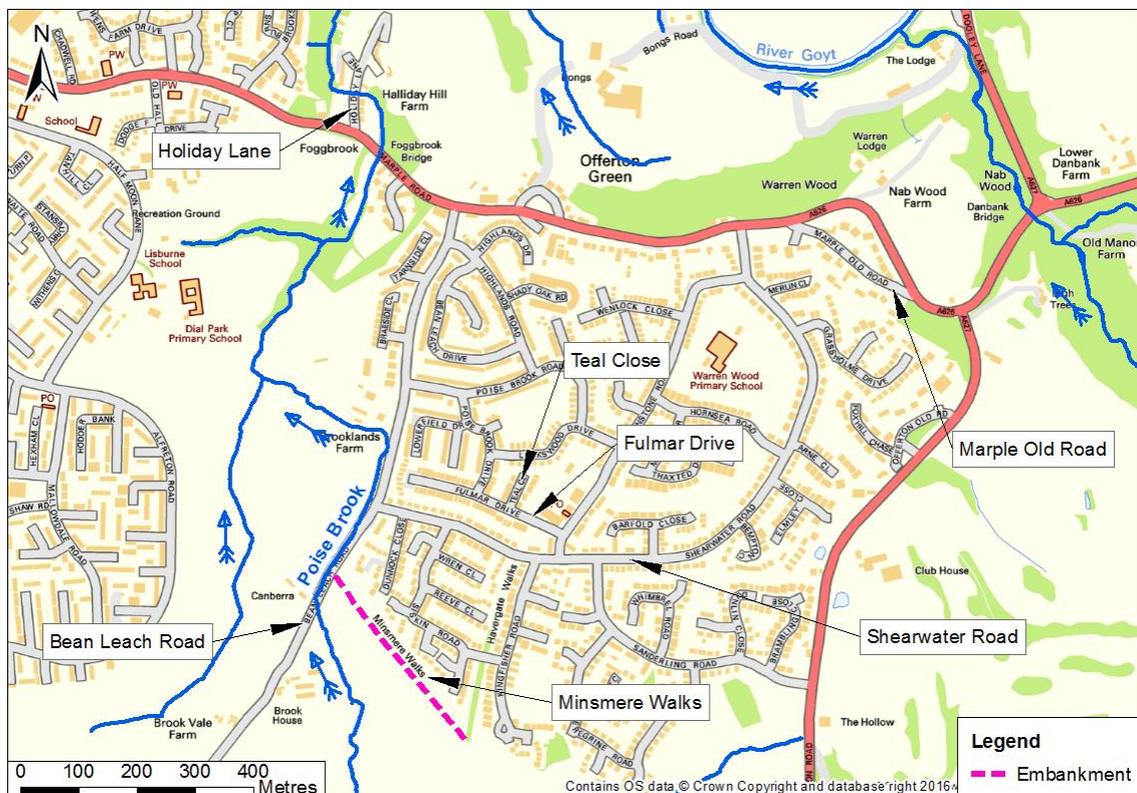
Figure 3.10 : Offerton Green site overview
