Birkenhead Priory Conservation Management Plan

Volume 2: Gazetteer

LLOYD EVANS PRICHARD

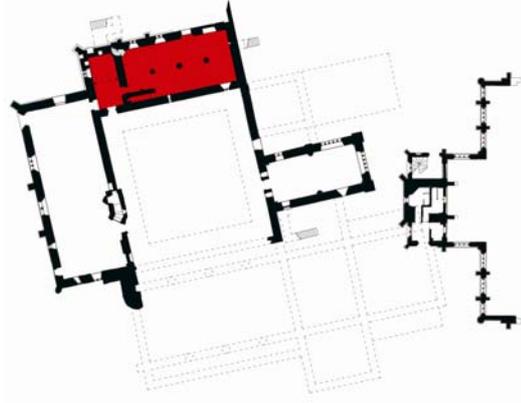
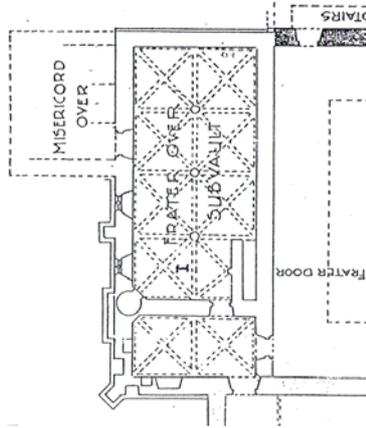
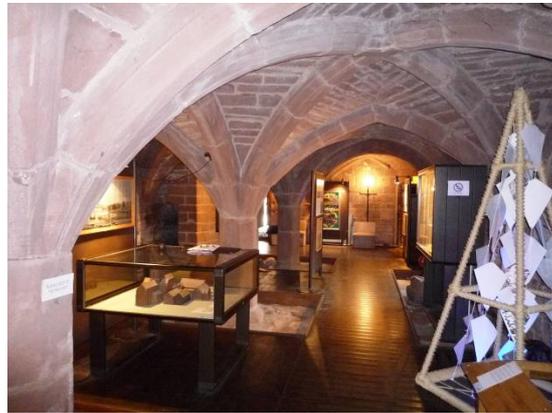
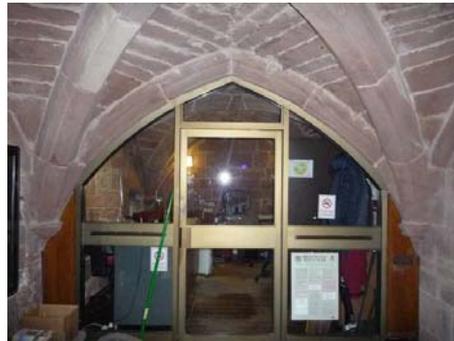
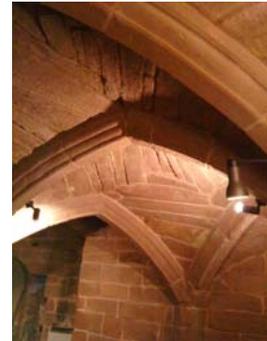
Interior – Undercroft and buttery

- Previously a buttery and storage area, or possibly dining
- The ground floor was adapted and converted to a museum by Wirral Borough Council in 1986.

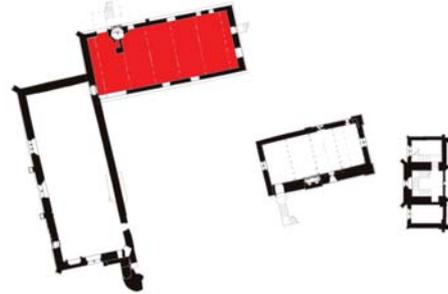
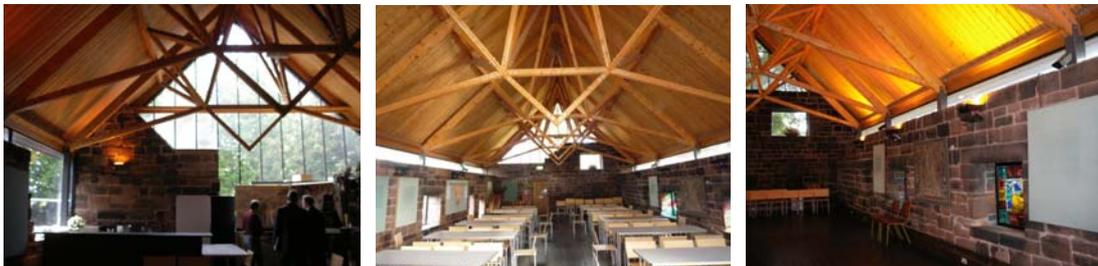
Interior – The refectory

- The upper floor remained a consolidated ruin until 1993, when it was roofed over in a contemporary manner to provide a space for concerts, educational events and weddings. The new roof structure sits lightly upon the old fabric.

- The former **refectory** is a large space, measuring 46 ft (14.02 m) by 22 ft (6.7 m). It is now used as an education room.
- Little original fabric remains; the most significant elements are the doorway on the north side which communicated with the northern addition, and a section of wall at the west end that marks the separation between the refectory and guest room.
- The prevailing character of the space now belongs to the remodelling of 1993, with a dramatic inverted timber roof truss.
- The smaller rectangular windows contain stained glass, including a charming representation of Noah releasing the dove from the ark (from St Peter's church, Birkenhead, demolished in 1994) and two specially commissioned panels by Martin Donlin, 1992, one biblical/monastic in theme and the other showing a modern shipyard worker.

1. Structural movement and possible questionable detailing of new 1993 roof structure.
2. Inadequate access up into the first floor refectory (external, uncovered, inaccessible for more heavily disabled users)

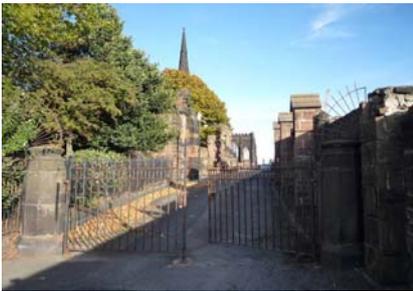
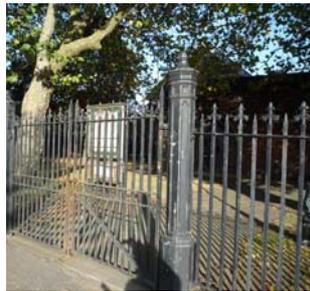
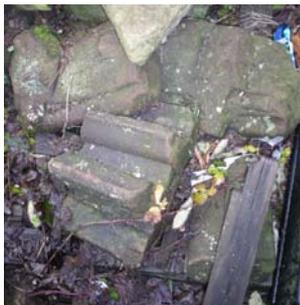
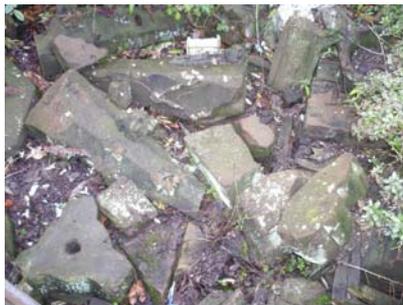
External, various locations around site

- The boundary wall of the medieval priory, shown in part in the King illustration from 1656 (illustration top left) had disappeared by the 18th century.

<p>Specific items for consideration:</p> <ul style="list-style-type: none">• The third section of the northern boundary wall is in need of repair.
<p>Relevant Issues & Policies: 4.1.5, 4.3.1, 4.3.2, 4.4.1, 4.6.3</p>
<p>Key references (Author/Year/Page): None</p>
